## DEGREE IN TECHNICAL ARCHITECTURE AND BUILDING FINAL DEGREE PROJECT

### FIRE SPREAD ACROSS INNER COURTYARDS FAÇADES

**Author:** Esteve Gonzàlez Cuxart

**Call:** April 2020

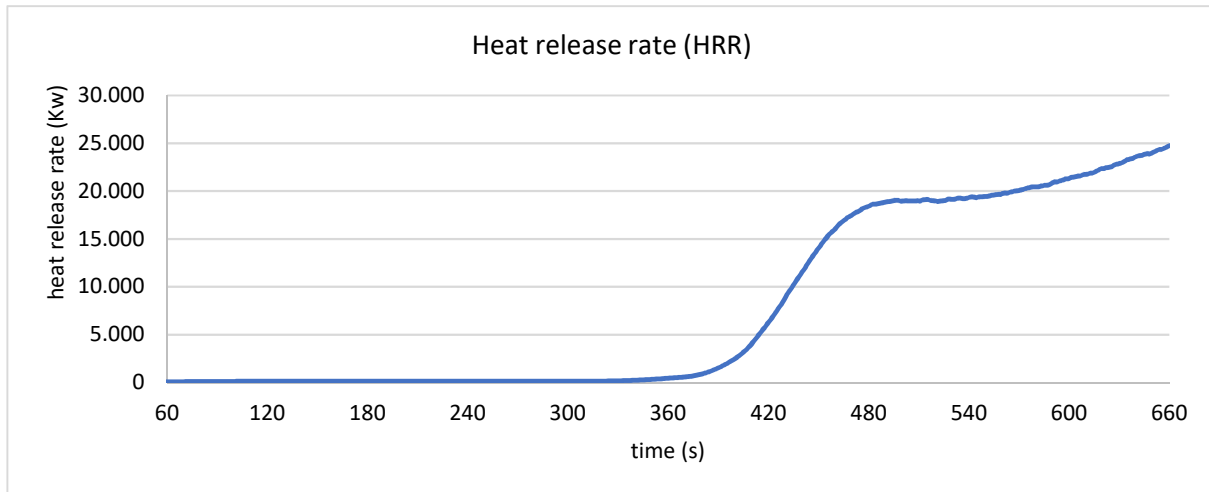
During the first five minutes (300s) most of the heat generated is lost by the conduction through the walls, as we see in Graph 3, where it almost does not increase and remains constant.

Graph 3. Graphical representation of the HRR parameter using a moving average trend line. The mobile line smooths out data variations, showing the trend more clearly.

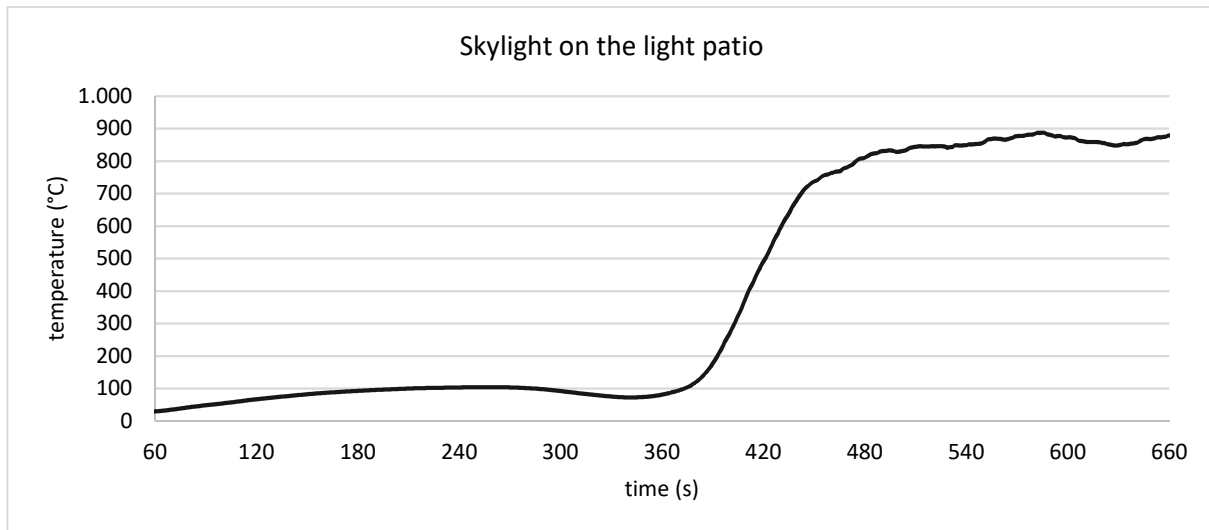
At the same time, note that the temperature curve in Graph 4 begins to decline because of low oxygen levels. At this moment, it's a ventilation limited fire.

Graph 4. Temperature in the skylight located 2.30 meters high and centered on the light patio plant view.

The breaking of the window overlooking the small airy patio JG55 alters the ventilation; increases the supply of oxygen to the combustion, increases the rate of heat release and raises the temperature through the flashover. From minute five to minute six (360 to 480s) the temperature rises from 100°C to 800°C while a fire is fuel controlled. The temperature is maintained until the end of the simulation with variations of  $\pm 100^\circ\text{C}$  and a maximum value of 987°C.

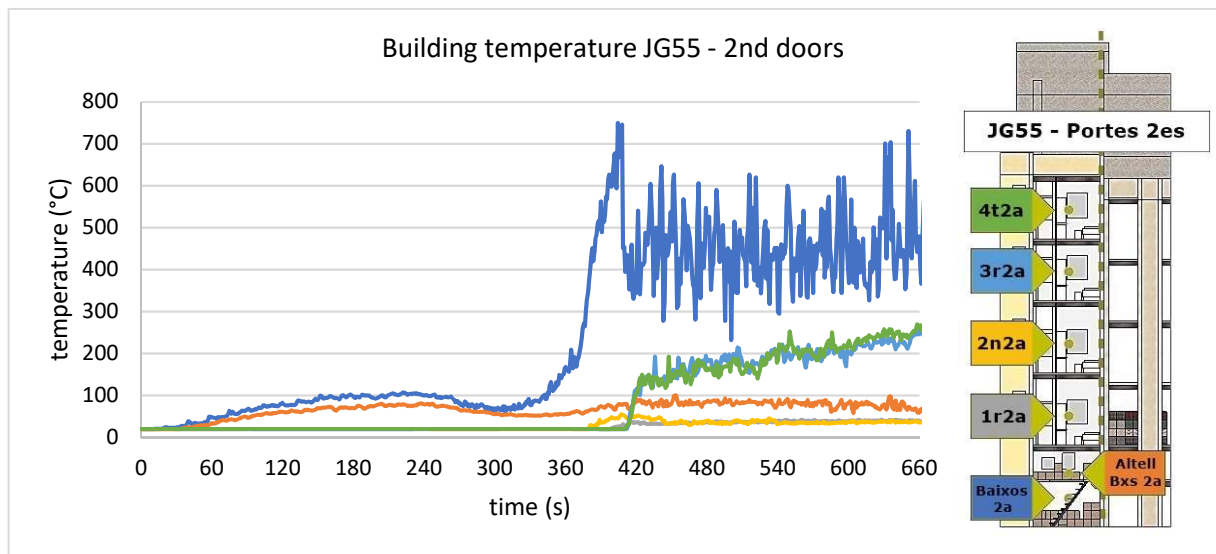
Graph 5. Ambient temperature monitoring in the second ground floor and in each of the second doors of the JG55 building.

The distribution of temperatures from highest to lowest is the following: 783°C at 2nd ground floor, 269°C at 4th 2nd, 258° at 3rd 2nd, 100°C at loft, 55°C at 2nd 2nd and 42°C at 1st 2nd.

There is a stratification of the temperature of the different floors around two strips with similar values. On the one hand the 1st and 2nd floors (42-55°C), and on the other the 3rd and 4th floors (258-269°C). The loft area, despite communicating with ground floor, has maximum temperature of 100°C.

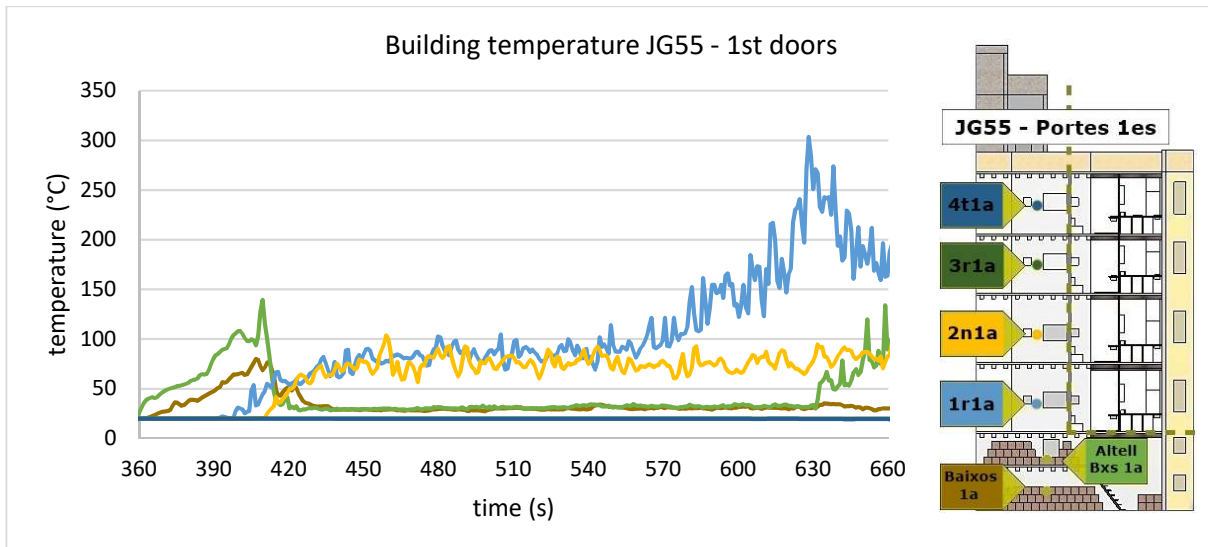
Graph 6. Ambient temperature monitoring in the first ground floor and in each of the first floor doors of the JG55 building.

As for the first doors, the highest temperature values are in the 1st floor with 303°C. It is known that this floor reached the fire situation developed, compatible with the temperatures reached. However, the simulation does not occur as it was not foreseen to put combustible furniture inside.

No change in temperature is detected on the 3rd and 4th floor as the windows were not broken and therefore no smoke inside. The distribution of temperatures from highest to lowest is the following: 303°C in the 1st, 103°C in the 2nd, 139°C in the loft and 80°C in the ground floor.

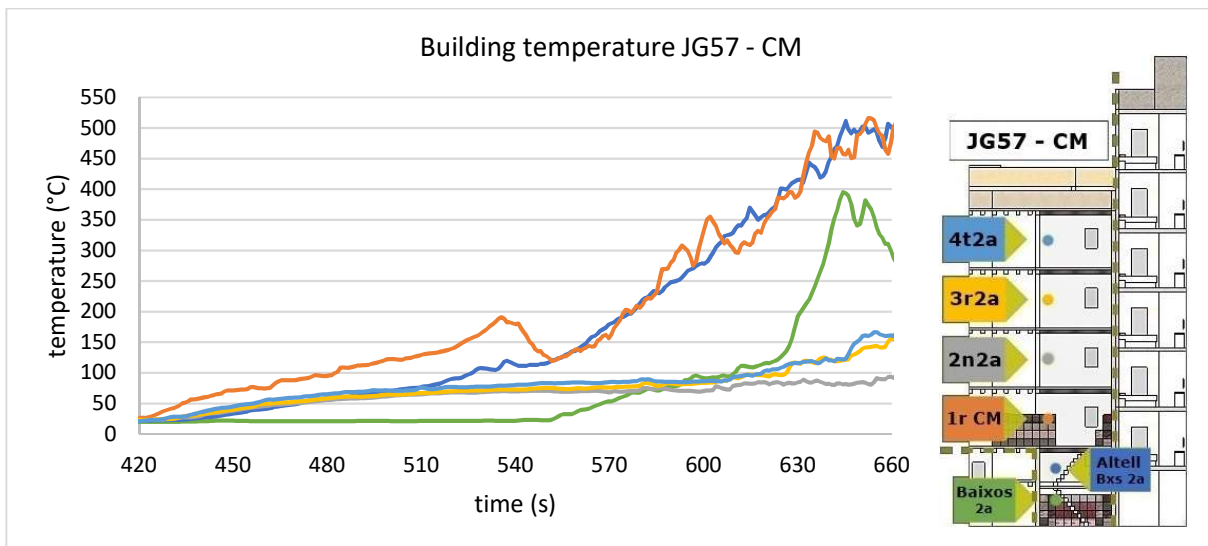
Graph 7. Ambient temperature monitoring in the second doors of the JG57 building and in the ground and first floor of the CM building.

The JG57 building has the peculiarity that it gives access to the 2nd, 3rd and 4th floors of the CM building. As in Graph 5, these floors show increasing temperature values in favor of the higher floors with 93°C, 166°C and 157°C respectively. Highest temperature values are in spaces where the textile material is stored and burn completely: 516°C on the first floor, 511°C on the loft and 395°C on the ground floor. The maximum temperature per room ordered from highest to lowest is the following: 1st floor, loft, 2nd ground floor, 4th 2nd, 3rd 2nd and 2nd 2nd.

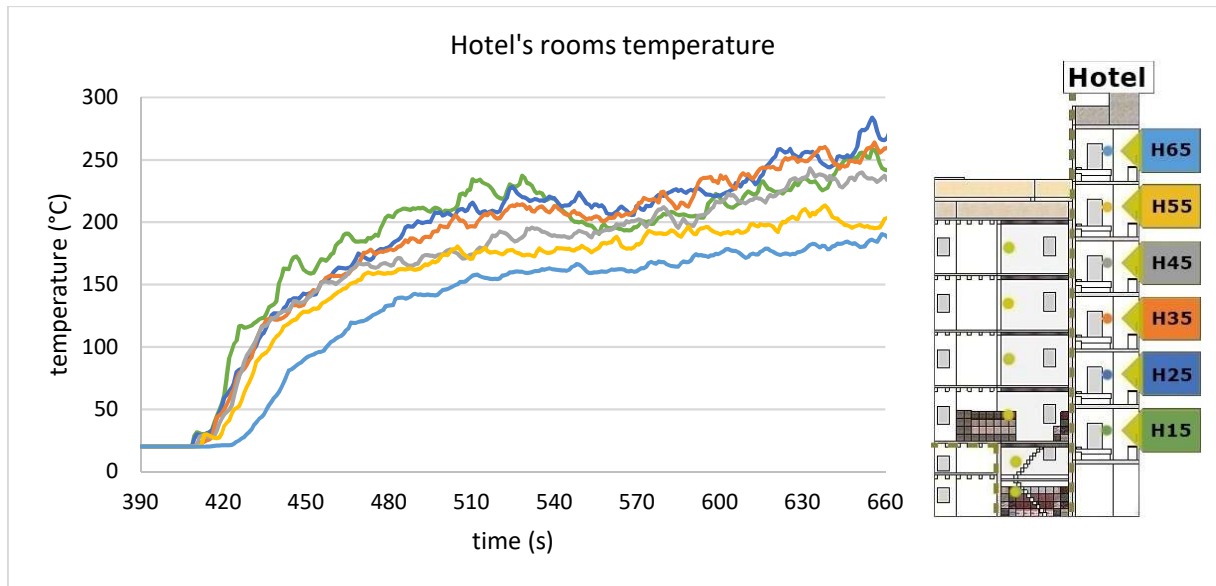
Graph 8. Monitoring ambient temperature monitoring in the Hotel's rooms.

The hotel building, the most constructively modern, also has windows that open directly to the light patio. These are the rooms "5" on each floor and the windows from protected stairwell. Let's look at the different effects of fire:

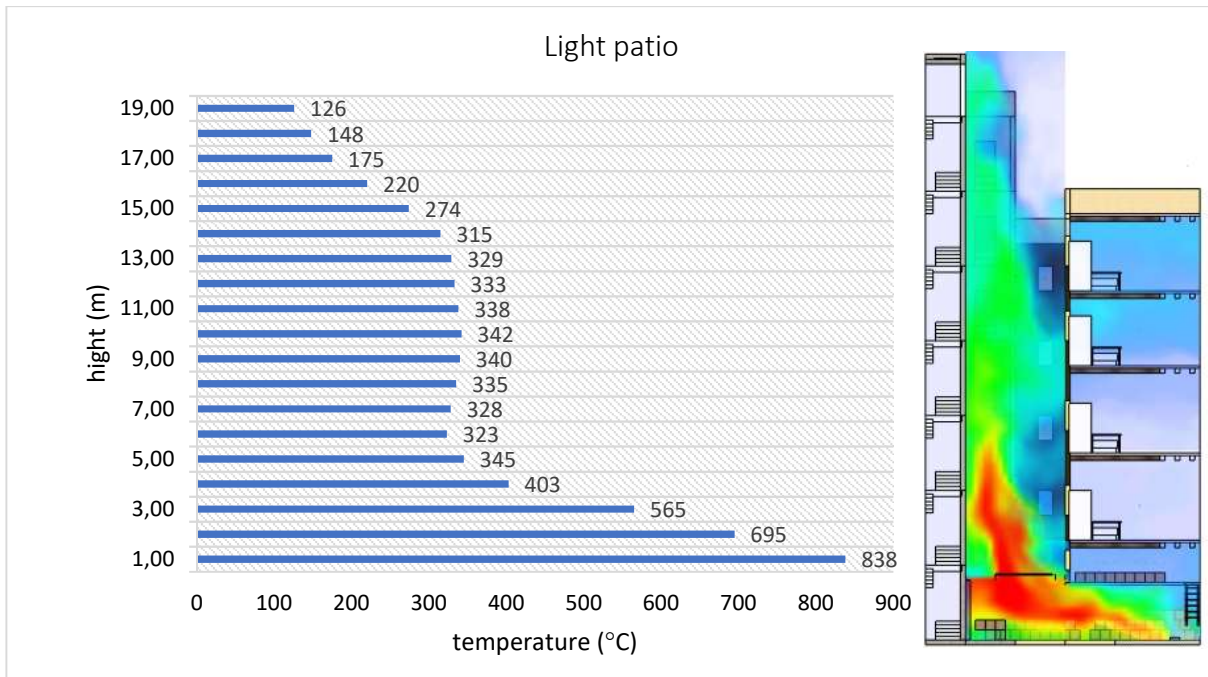
Graph 9. Results of the column of thermoparells in the center of the light patio, that are separate one meter between them from the ground of the light patio. It corresponds to the average temperature of the period that goes from 390 to 490s, which coincide with the beginning of the exit of gas and flames through the light patio.

The vertical distribution of temperatures inside the light patio is homogeneous in the central section and it varies at the upper and lower ends, where it decreases and increases respectively.

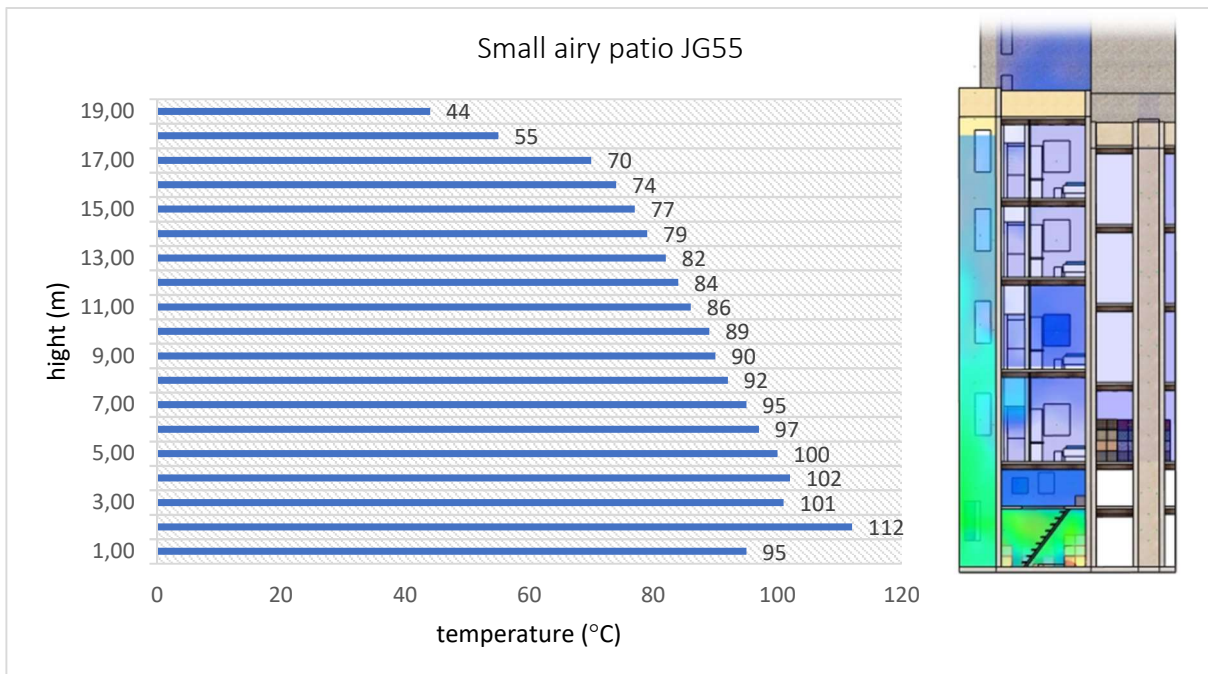
Graph 10. Results of the column of thermoparells in the center of the small airy patio JG55, that are separate one meter between them. It corresponds to the average temperature of the period that goes from 260 to 360s, just before the reversing the sense of air circulation (see Graph 1).

The vertical temperatures distribution inside the small airy patio decreases with height and keep the different behavior in the upper and lower ends of the same way than the light patio.
